Manhole Inspection Summary

Manhole # S13K__003MH

Inspection ☐ Is Incomplete Rating: **3) Fair**

Insp Date: **7/1/09 11:46 AM**

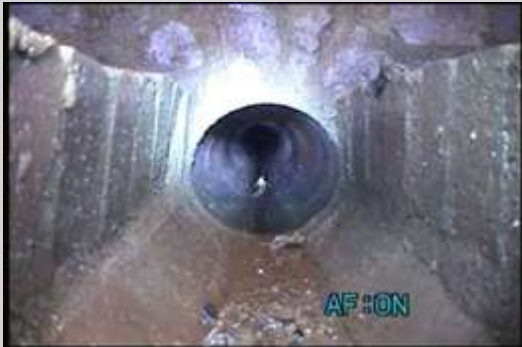
12 O'Clock Outflow

6 in. Circular Gravity Sewer
Pipe Out @ 12 O'Clock

Pipe Height: **6** (in.) Rod and Bar (Angled)
Pipe Material: **Clay** ☐ Pipe Lined
Invert Depth: **12.02** (ft.) Flow Characteristics: **None**
Deposits: ☒ None ☐ Mud ☐ Sludge ☐ Debris ☐ Grease
Silt Depth: **0** (in.) Deposits Extent:
Infiltration: **None** Pipe Seal Cond: **Sound**
